# *Analysis on an Electromagnetic Compatibility Engineering Trouble Shooting Case of Electric Vehicle*

**Abstract**—In the situation that an electric vehicle tested in accordance with GB/T 18387-2017 and GB 14023-2011 but not meets the requirements of the standards, the motor controller (PMU) and air conditioning compressor (ACCM) are proved to be the main electromagnetic disturbance sources according to the scientific elimination method. The mechanism of electromagnetic disturbance is also analyzed and studied. Considering the key factors affecting mass production of vehicles, an engineering optimization solution is proposed to enable radiation emission of the electric vehicles meet the requirements of national standards.

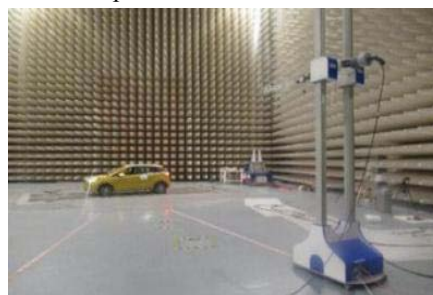
Fig.1 Test setup

located on the left side of the vehicle. The test setup is shown in Fig. 1. The test results of LV mode are shown in Fig. 2. When tested in accordance with GB/T 18387-2017, the magnetic field test result at a vehicle speed of 16km/h exceeds the limit line with the antenna located on the left side of the vehicle and parallel to the vehicle(L-X-16 mode), as shown in Fig. 3. Thus, trouble shooting of narrowband test and magnetic field test are performed.

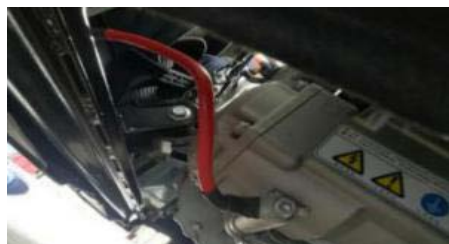
Fig.11 ACCM after trouble shooting

For the reason that the radiation emission in area B exceeds the limit line, it is analyzed that the ACCM is not well grounded, so that the common mode interference generated by the switching power supply is nowhere to be released<sup>[4]</sup>. After trouble shooting, the picture is shown in Fig. 11 and the red line is the ground wire.
