Measurement of Microwave Propagation Characteristics along a Fiberglass-Reinforced Plastic Mortar Pipe Using an Electro-Optic Sensor

Abstract We have proposed a new nondestructive inspection method for fiberglass-reinforced plastic mortar (FRPM) pipes using microwave guide-mode propagation and photonic techniques. This method is based on the precise measurement of a microwave guided-mode propagated along an FRPM pipe-wall by use of an electro-optic (EO) sensor. In the previous research, we have confirmed that microwave can propagate along the FRPM pipe-wall as a guided-mode, and the microwave transmission characteristics propagated through the FRPM pipe are affected by defects or cracks in FRPM pipe-walls. By measuring transmission characteristics and electric field distributions by using the EO sensor precisely, we can detect small defects or cracks in/on the FRPM pipe nondestructively.

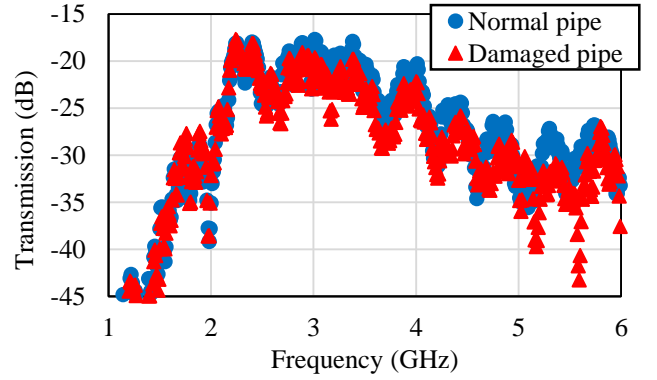
Fig.5 Microwave transmission characteristics propagated along the normal/damaged FRPM pipe.

Fig.5 shows a measurement results of microwave transmission characteristics when the EO sensor was set at the end of the FRPM pipe with the position of $r = 0$ shown in Fig.4 (b). There are two curves in Fig.5; one is a microwave transmission characteristics for the normal FRPM pipe and the other is for the damaged FRPM pipe. We can see a clear difference between the two results.

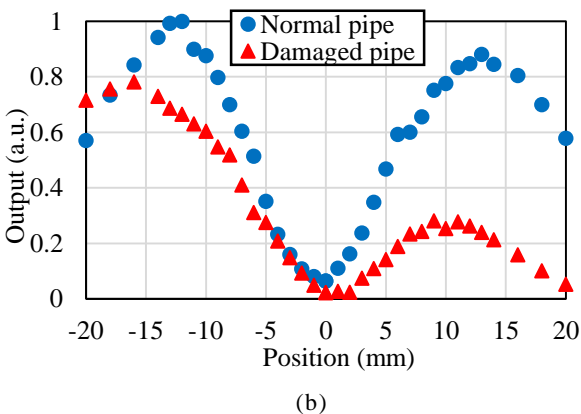
Fig.6 Electric field distributions of microwave propagated along the normal/damaged FRPM pipe at (a) 2.4 GHz and (b) 6 GHz.

Fig.6 shows the measured electric field distributions at (a) 2.4 GHz and (b) 6 GHz by scanning the EO sensor at the end of the FRPM pipe, as shown in Fig.4 (b). In the results of the damaged pipe, the microwave signal levels were decreased. We believe that these change were caused by the cracks in the FRPM pipe. Since there is only one guided mode of the microwave propagating along the FRPM pipe at 2.4 GHz as shown in the dispersion curve in Fig.3 (a), the microwave amplitude is merely distorted by the defects or cracks. On the other hand, at 6 GHz there are three microwave guided modes

propagating along the FRPM pipe as shown in the dispersion curves of Fig.3 (a). Then the microwave guided modes can be not only distorted but also mutually coupled by defects or cracks. Therefore, the change in the field profile at 6 GHz was rather definite compared with that at 2.4 GHz.

We can see that there is a big drop around the position of 13 mm between the normal and damaged FRPM pipe at 6 GHz in Fig.6 (b). Therefore, we believe that we can detect small cracks by measuring a microwave electric field distribution by use of the EO sensor precisely.
