## Simulation-based Analysis of FF Behavior in Presence of Power Supply Noise

出典 : The 23rd IEEE International On-Line Testing Symposium (IOLTS 2017), pp.151-156

概要 : 半導体デバイスの微細化, 低電圧化により電源ノイズが回路動作に影響を与えることが問題になっている. 特にメモリ素子 (SRAM) ではビット反転の誤動作 (エラー) が発生することが知られている. 今後更にデバイスの微細化が進むと SRAM と同様の回路構造を持つフリップフロップ (FF) でも電源ノイズの影響が顕著になる可能性がある. 本論文では FF においても電源ノイズによる SRAM と同様もしくは他の誤動作の発生の有無を解析した. その結果, ビット反転エラーおよびキャプチャエラーが発生するところを確認した. またその発生原因を解明し, 誤動作対策方法を提案する.

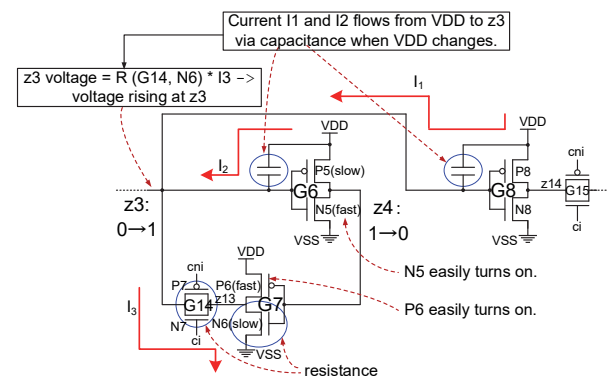
Fig. 2 Causes of bit-flip error.

When the logic value of  $z3$  changes from 0 to 1 and the logic value of  $z4$  changes from 1 to 0, the bit-flip error occurs. Two causes of the error are considered (Fig. 2). The first one relates to the rising voltage of the  $z3$  node, which is caused when the power supply voltage returns to a normal voltage level. A current from VDD to  $z3$  flows through parasitic capacitances of gate-source terminals of transistors P5 and P8 when the power supply voltage changes. The current flows to GND through gate G14 and transistor N6 of G7. At this time, both the flowing current and resistive components of gates on the current path cause a rising voltage of the  $z3$  node.

The second cause relates to threshold variations of transistors. The threshold voltage of gate G6 is (nMOS, pMOS)=(fast, slow) and that of gate G7 is (nMOS, pMOS)=(slow, fast). Thus, N5 of G6 easily turns on, and the voltage of node  $z4$  easily goes to a low level. Similarly, P6 of G7 easily turns on, and the voltage of node  $z3$  easily goes to a high level.

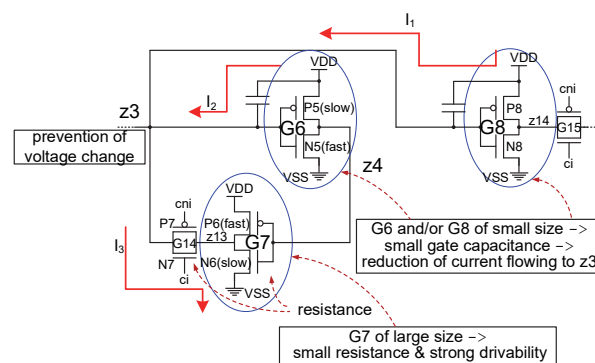
Fig. 3 Countermeasure for bit-flip error.

The main cause of error,  $z3=0 \rightarrow 1$  and  $z4=1 \rightarrow 0$ , is the voltage rising at  $z3$  generated by the current from VDD to  $z3$  through the parasitic capacitance and the resistive component of the gate. To prevent the error of, those values need to become small (Fig. 3). The size of gate G6 and/or G8 becomes small. Since this change results in the capacitance of G6 and/or G8 becoming small, the current from VDD to  $z3$  becomes small. In addition, the size of gate G7 becomes large. Since this change results in the resistance of G7 becoming small, the voltage rising at  $z3$  becomes small even if there is current flow. Moreover, since the drivability of G7 becomes strong, G7 preferentially produces a proper output value, and it becomes difficult for the error to occur.
