Suppression of electromagnetic radiation emission from electric vehicles: an engineering practical approach

Guo Jiandong, Wang Chuanqi, Ding Yifu, Jiang Li, Lv Yan
 China Automotive Technology & Research Center Co., Ltd.
 Tianjin, China
 guojiandong@catarc.ac.cn

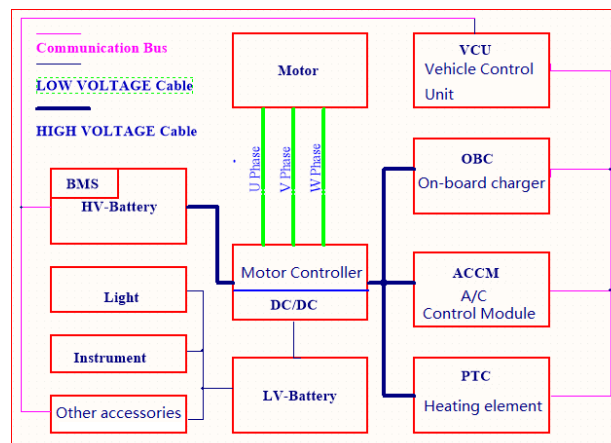
Fig 1. Topology diagram of the electrical system

controllers, DC / DC converters, high-voltage traction batteries. Comparing to traditional cars, EVs equipped with more electronic equipment, such as electric powered steering, air conditioning compressor and PTC heating element, brake vacuum pump, electronic parking brake, etc. High-voltage power electronic switching devices are very easy to produce electromagnetic interference through conduction, coupling or radiation, so there is a big challenge in developing the EMC performance of electric vehicle. In order to better analyze the electromagnetic compatibility of the vehicle, Figure 1 shows the topology diagram of the electrical system from one rectification project, which could give a general overview of the working principle and guiding the following research.

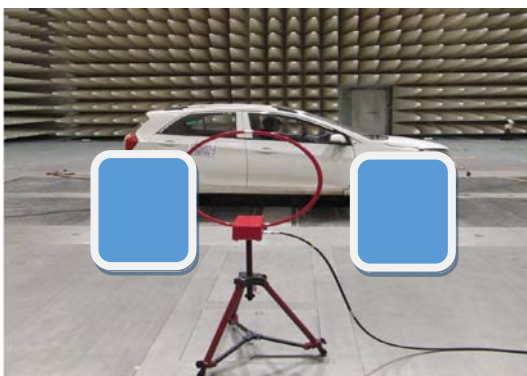
Fig.2 The loop antenna plane is parallel to the right side of the vehicle

The pre-compliance test has been carried out in the 10m semi-anechoic chamber. Preliminary result shows that the magnetic field from the right side of the vehicle exceeds the limit line seriously. The test setup is shown in Figure 2 and the test data is shown in Figure 4 and Figure 5. The electric field test setup is shown in Figure 3 which has passed the test. During the test, the motor controller unit, DC-DC converter and battery pack are operating in normal condition with all of the low-voltage components in working order. In addition, as the high integration of the on-board high voltage components, multiple components are installed in the limited space of the

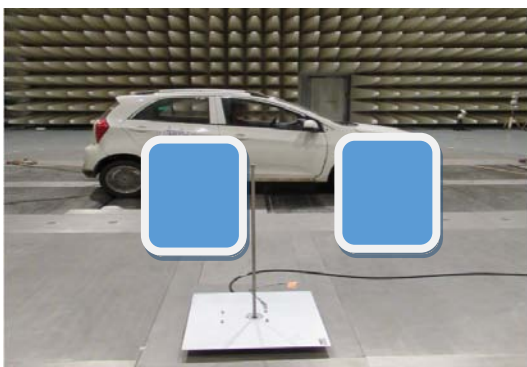
Fig.3 The rod antenna is located in the right side of the vehicle

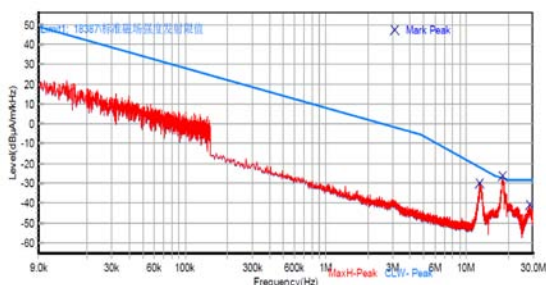
Fig.4 The loop antenna plane is parallel to the right side of the vehicle, 16km/h

By comparing the test results, the emission exceeds the limit line most serious when the magnetic field antenna plane is parallel to the right side of the vehicle. There is a peak around 12.5MHz by exceeding margin limit for 11.9dB. Another peak appears in 18.03MHz by exceeding 4.42dB.

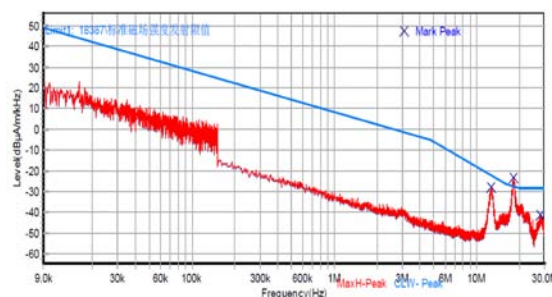
Fig.5 The loop antenna plane is parallel to the right side of the vehicle, 64km/h

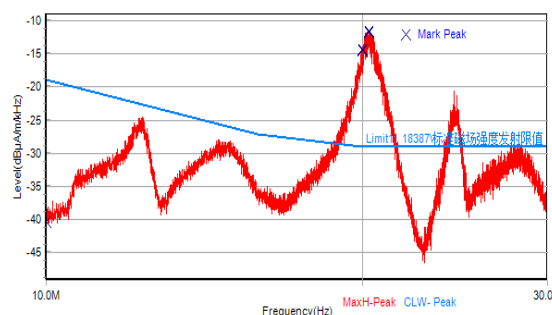
Fig.6 The loop antenna plane is parallel to the right side of the vehicle, 40km/h

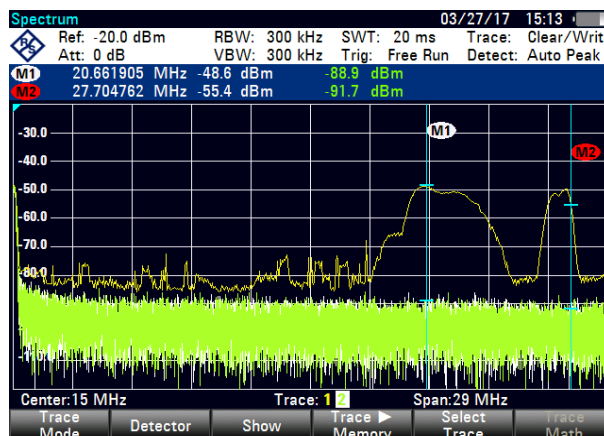
Fig.7 Scan result of High-voltage DC harness of motor controller in near field

front chassis, which are not easy to be disassembled and increase the difficulty to position the interference source. According to rectification experience, most of the interference sources are the on-board high-voltage components. In order to mitigate the interference, the source must be determined exactly using process of elimination. In the process, the on-board components are tested individually, after disconnecting A/C, PTC and on-board charger, leaving only the motor controller powered on, the results in Figure 6 still exceeds the standard limits, so the main source is determined to the motor controller. In the further step, hand-held spectrum analyzer is used for near field scanning, the near field scanning result of high-voltage DC harness near motor controller is shown in Figure 7.

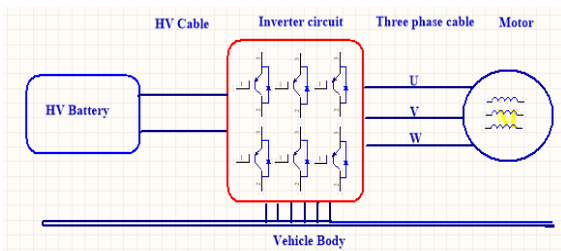
Fig.8 Simple topology of power system

The fast change rates of current and voltage directly cause the conduction and radiation emission problems. In addition, the parasitic parameters inside the IGBT during the operation of the inverter can also cause the problem of differential mode signal interference. The simple topology of the power system is shown in Fig.8. In Fig. 9 two differential mode signal interference paths are shown. One path (Inverter differential mode path) is the interference source flows through the upper and lower halves of inverter, and then back to the power battery. The other path (Motor circuit differential mode path) is the interference source flows from the HV-DC harness to the inverter and then to the motor, and finally returns to the HV-DC harness. Figure 10 shows two common mode interference paths. Common mode interference problem is caused by ground potential difference between the inverter, motor and HV battery.

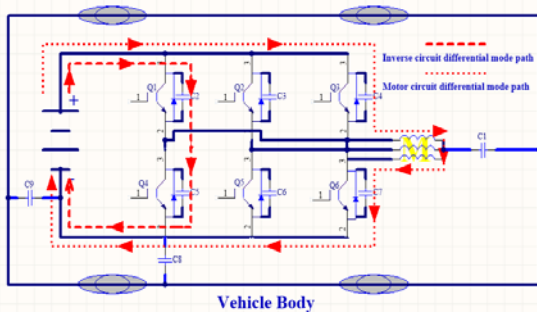
Fig.9 Analysis of differential-mode interference

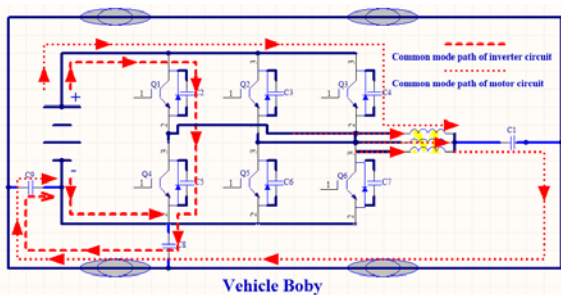
Fig.10 Analysis of common-mode interference

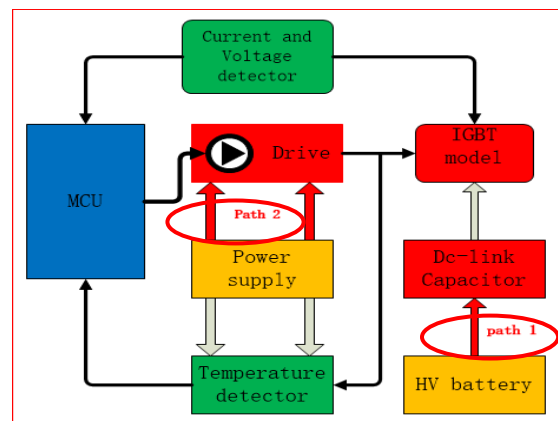
Figure 11 Rectification measures imposed location

In order to solve the common mode and differential mode radiation emission generated by motor controller, there are two improvements for path 1 and path 2 in Figure 11. Firstly, in path 1, applying three capacitors on negative and positive of high voltage power supply port. The 3dB bandwidth at the

resonance point of the three capacitors lies exactly at the frequency band where the noise is needed to be filtered. Then these six capacitors are encapsulated in a 3D-printed supporting structure, which could be mechanically fitted in the motor controller, in a both time and cost effective way, from the engineering practical point of view this is also a mass-producible rectification approach. Secondly, in path 2, the L-C filter circuit is built using the resonance characteristics of capacitors and inductors, as shown in Figure 12. The structure and parameters of the filter are obtained through simulation and test, which have good filtering effect. Figure 13 is the simulated insertion loss diagram for LC filter circuit. The formulation used to design the resonant frequency of a filter is shown in (1). Verified by hand-made filter board, filter PCB is carefully designed and fitted in motor controller. The installation location and method is shown in Figure 14, which not only meet the needs of rapid rectification but also to ensure that rectification does not affect other functions of product.

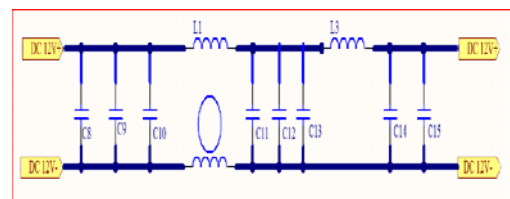
Figure 12 Control board to driver board circuit filter diagram

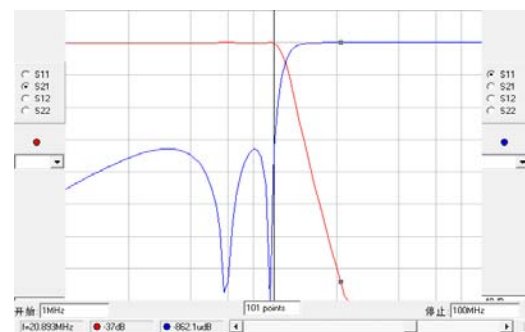
Figure 13 Simulation insertion Loss of filter

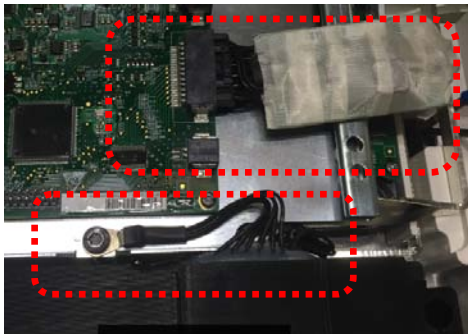
Figure 14 Installation location and method

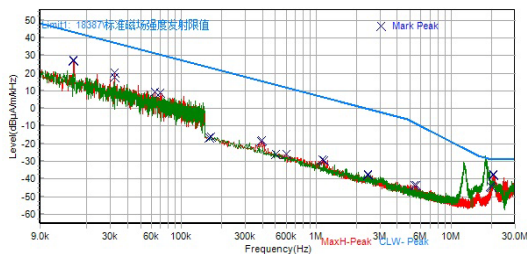
Figure 15 Vehicle speed 16km/h, loop antenna plane is parallel to the right side of vehicle

After positioning the source of interference and applying rectification measures, the final test results are shown in Figure 15 to Figure 22.

The red line is the test result after rectifying, and the green line is the original test result.

Comparing the data, it can be founded that since the resonance is eliminated by the inductance and capacitance, the rectification methods has a major effect on the 10-30MHz frequency band, the maximum optimized margin is about 12 dB.

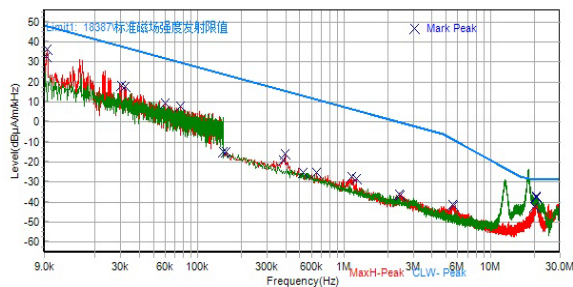
Figure 16 Vehicle speed 16km/h, loop antenna plane is perpendicular to the right side of vehicle

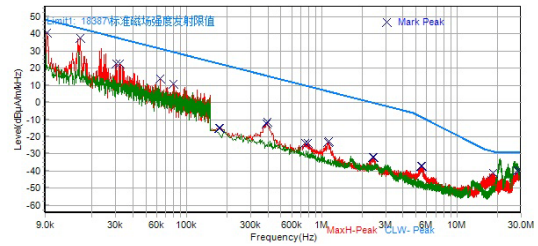
Figure 17 Vehicle speed 16km/h, loop antenna plane is parallel to the right side of vehicle

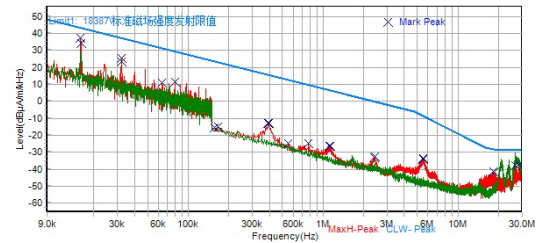
Figure 18 Vehicle speed 64km/h, loop antenna plane is parallel to the right side of vehicle
